Ice/Frost/Debris Assessment For Space Shuttle Mission STS-27R

(NASA-TM-102144) ICE/FROST/DEBRIS
ASSESSMENT FOR SPACE SHUTTLE MISSION
STS-27R, DECEMBER 2, 1988 (NASA) 200 p
CSCI 22B

ICE/FROST/DEBRIS ASSESSMENT
FOR
SPACE SHUTTLE MISSION
STS-27R
DECEMBER 2, 1988

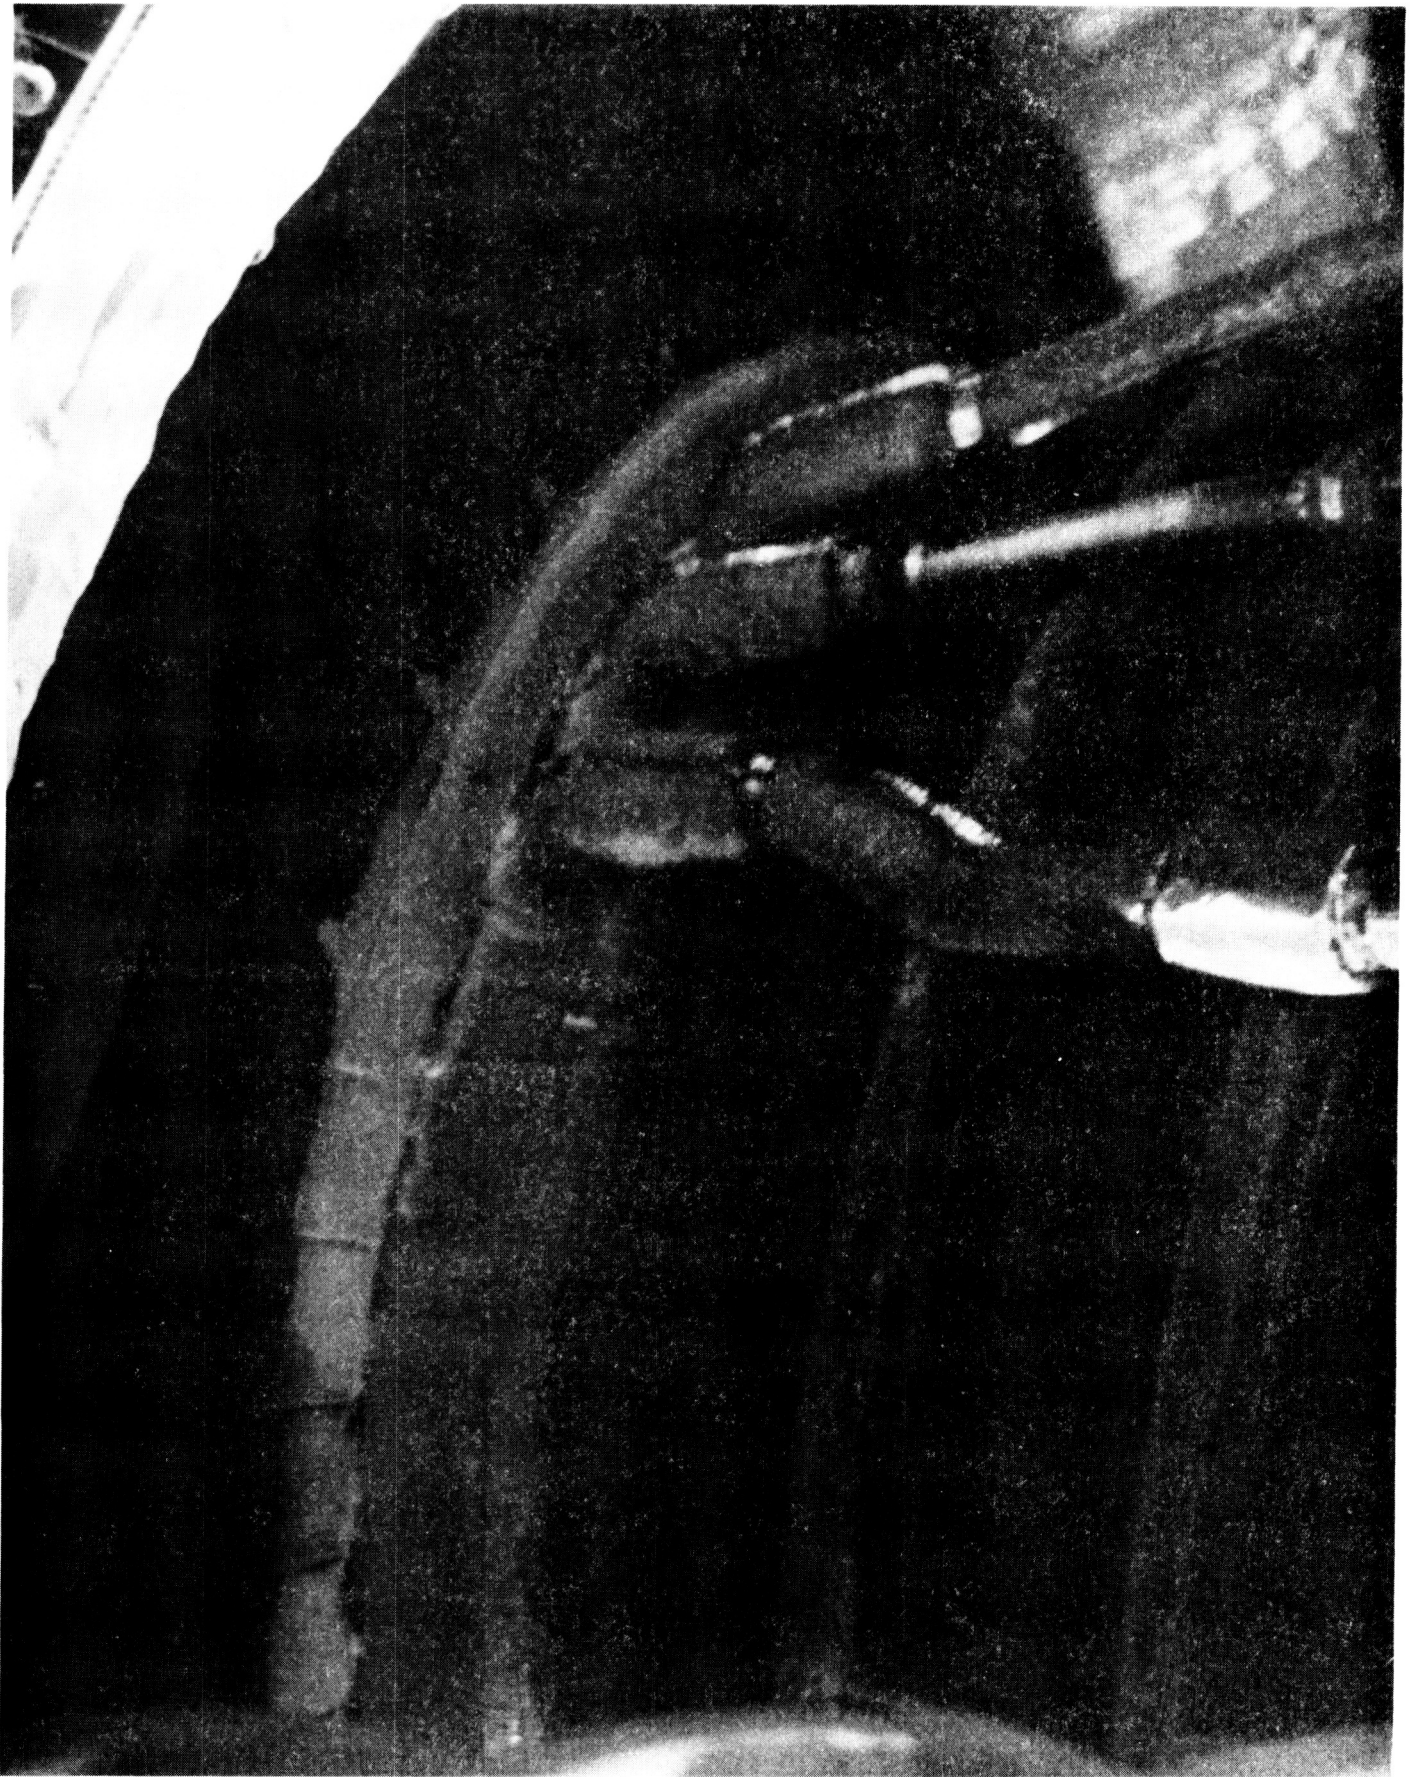
LIGHT FROST ACCUMULATION ON ENGINE MOUNTED HEAT SHIELD

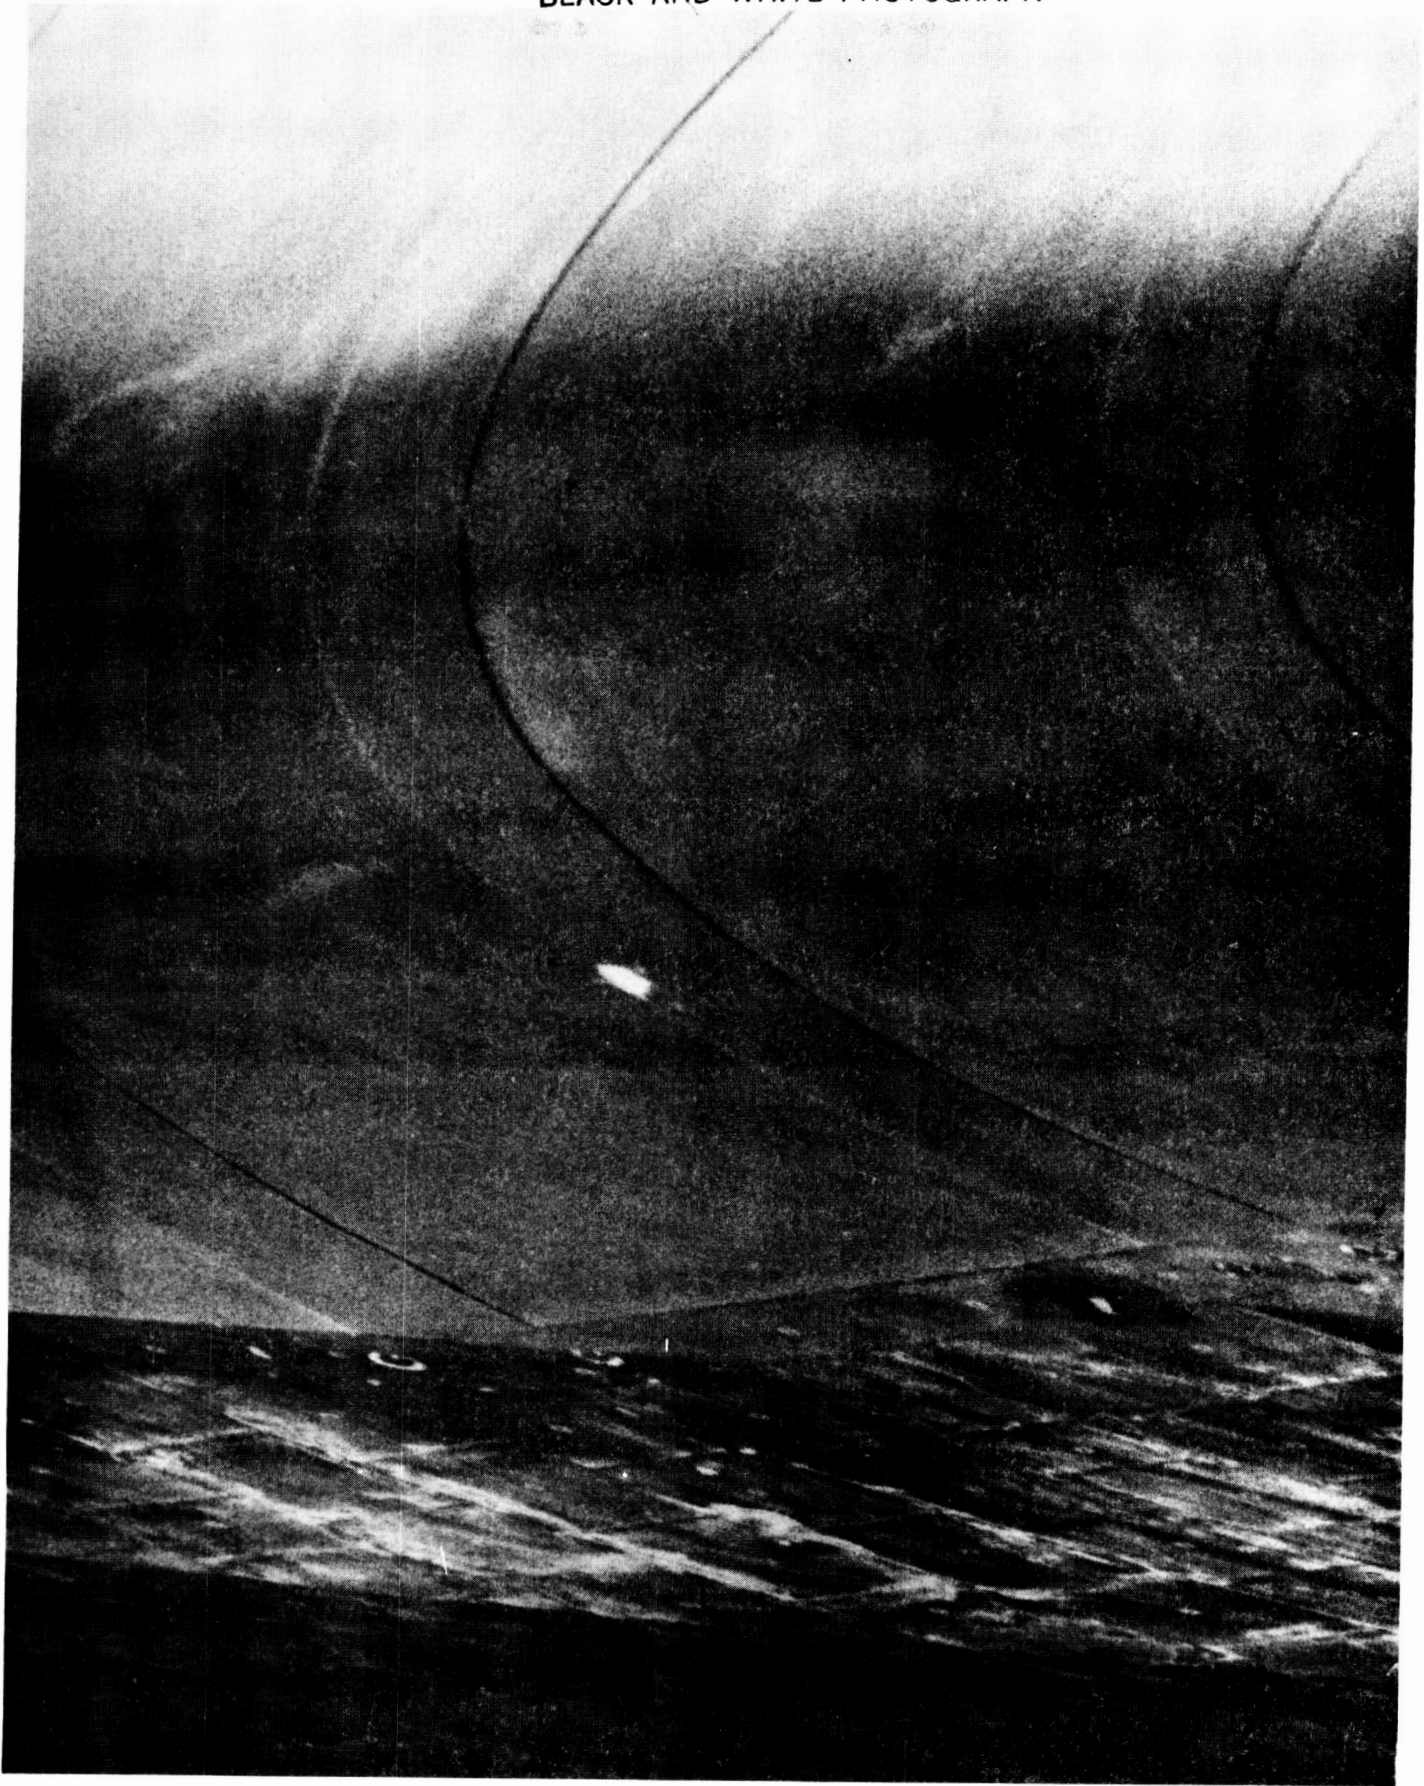
WHITE SPOT NOTED ON LH ORBITER WING LEADING EDGE RCC T-SEAL

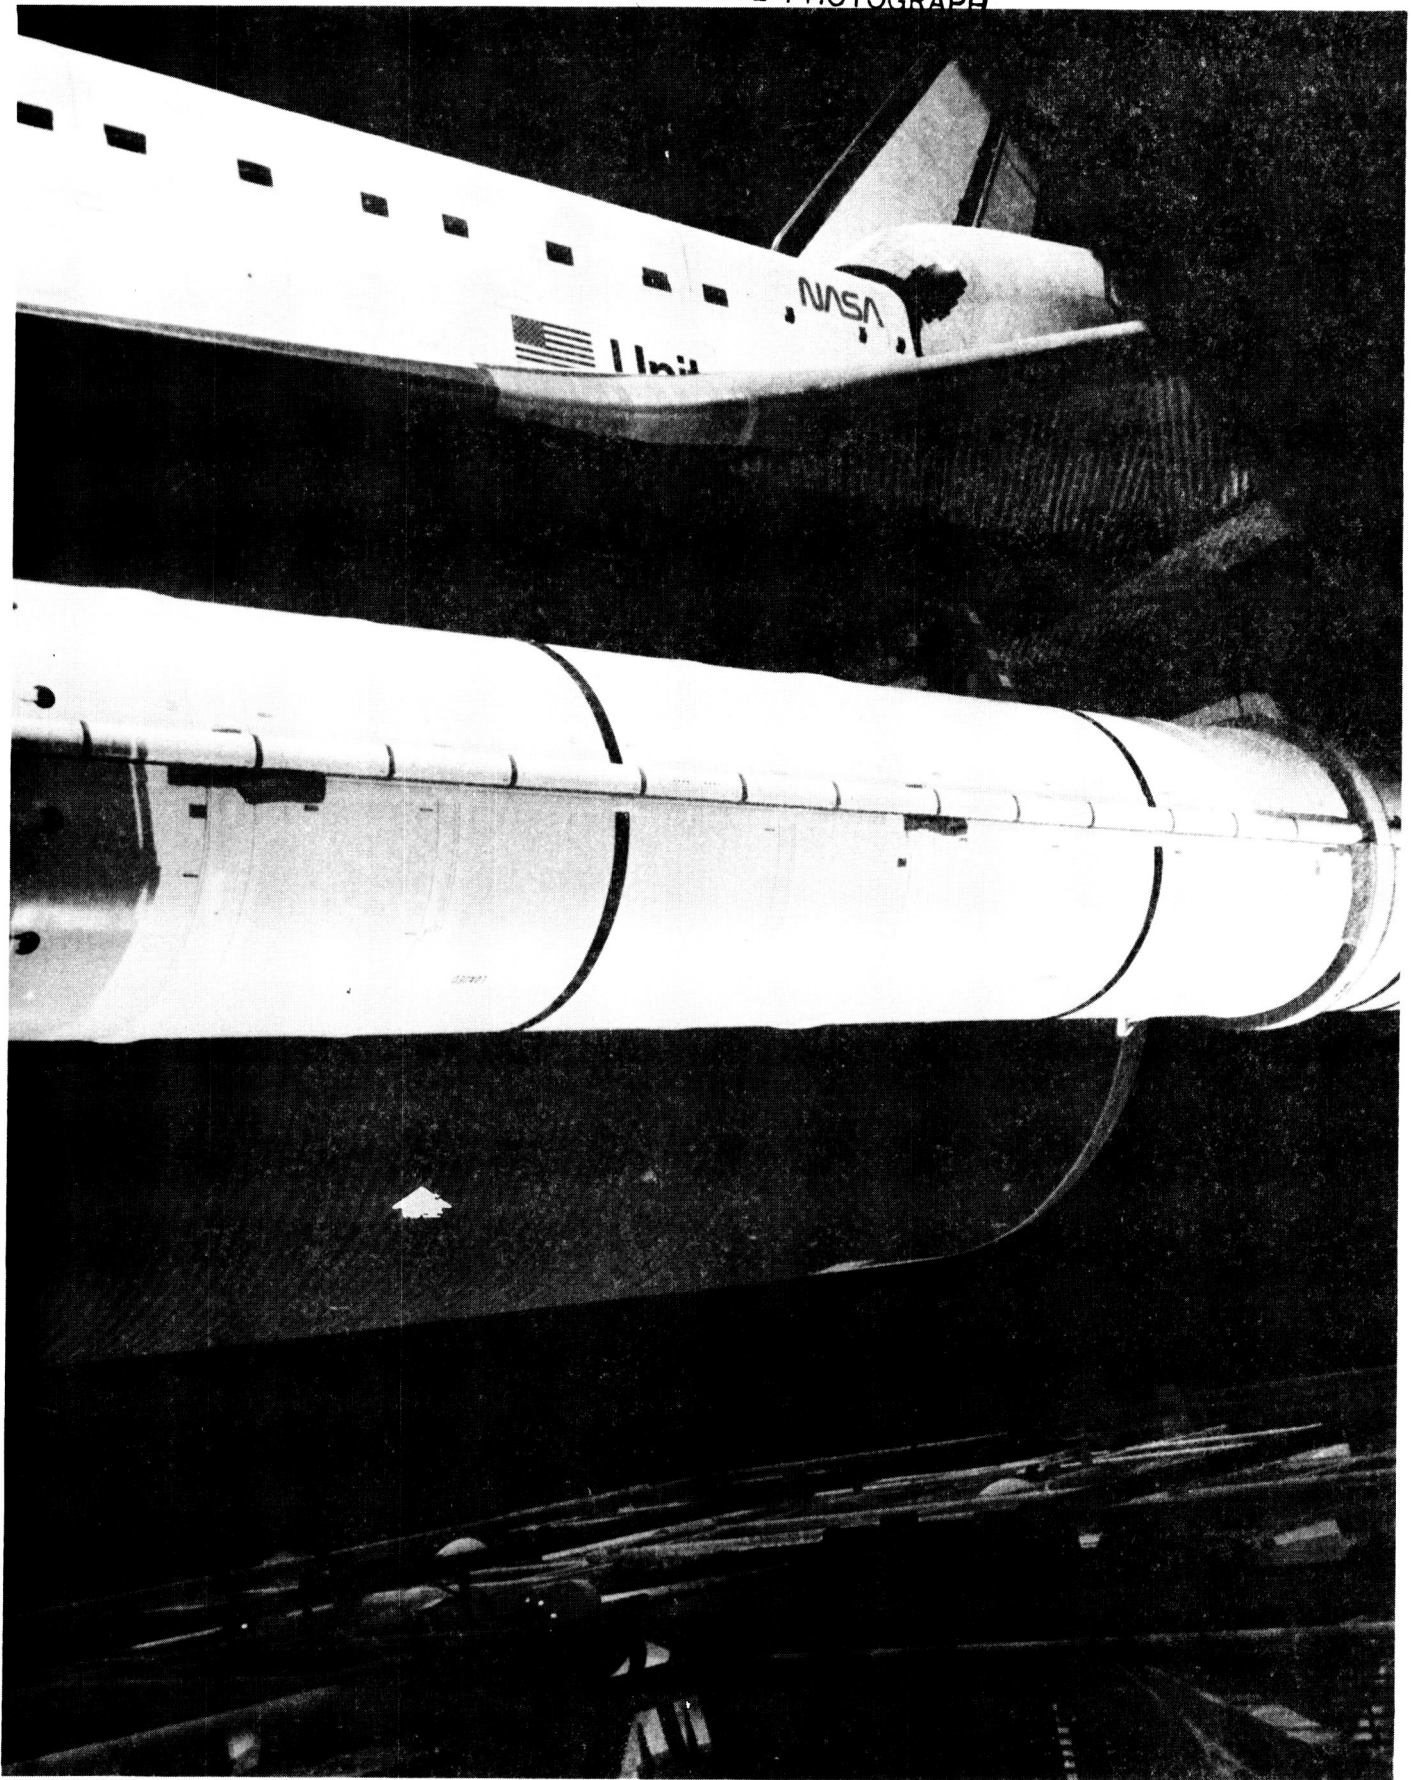
LIGHT ACREAGE FROST VISIBLE ON MID LH2 TANK
BARREL AT 315° DEGREES AZIMUTH

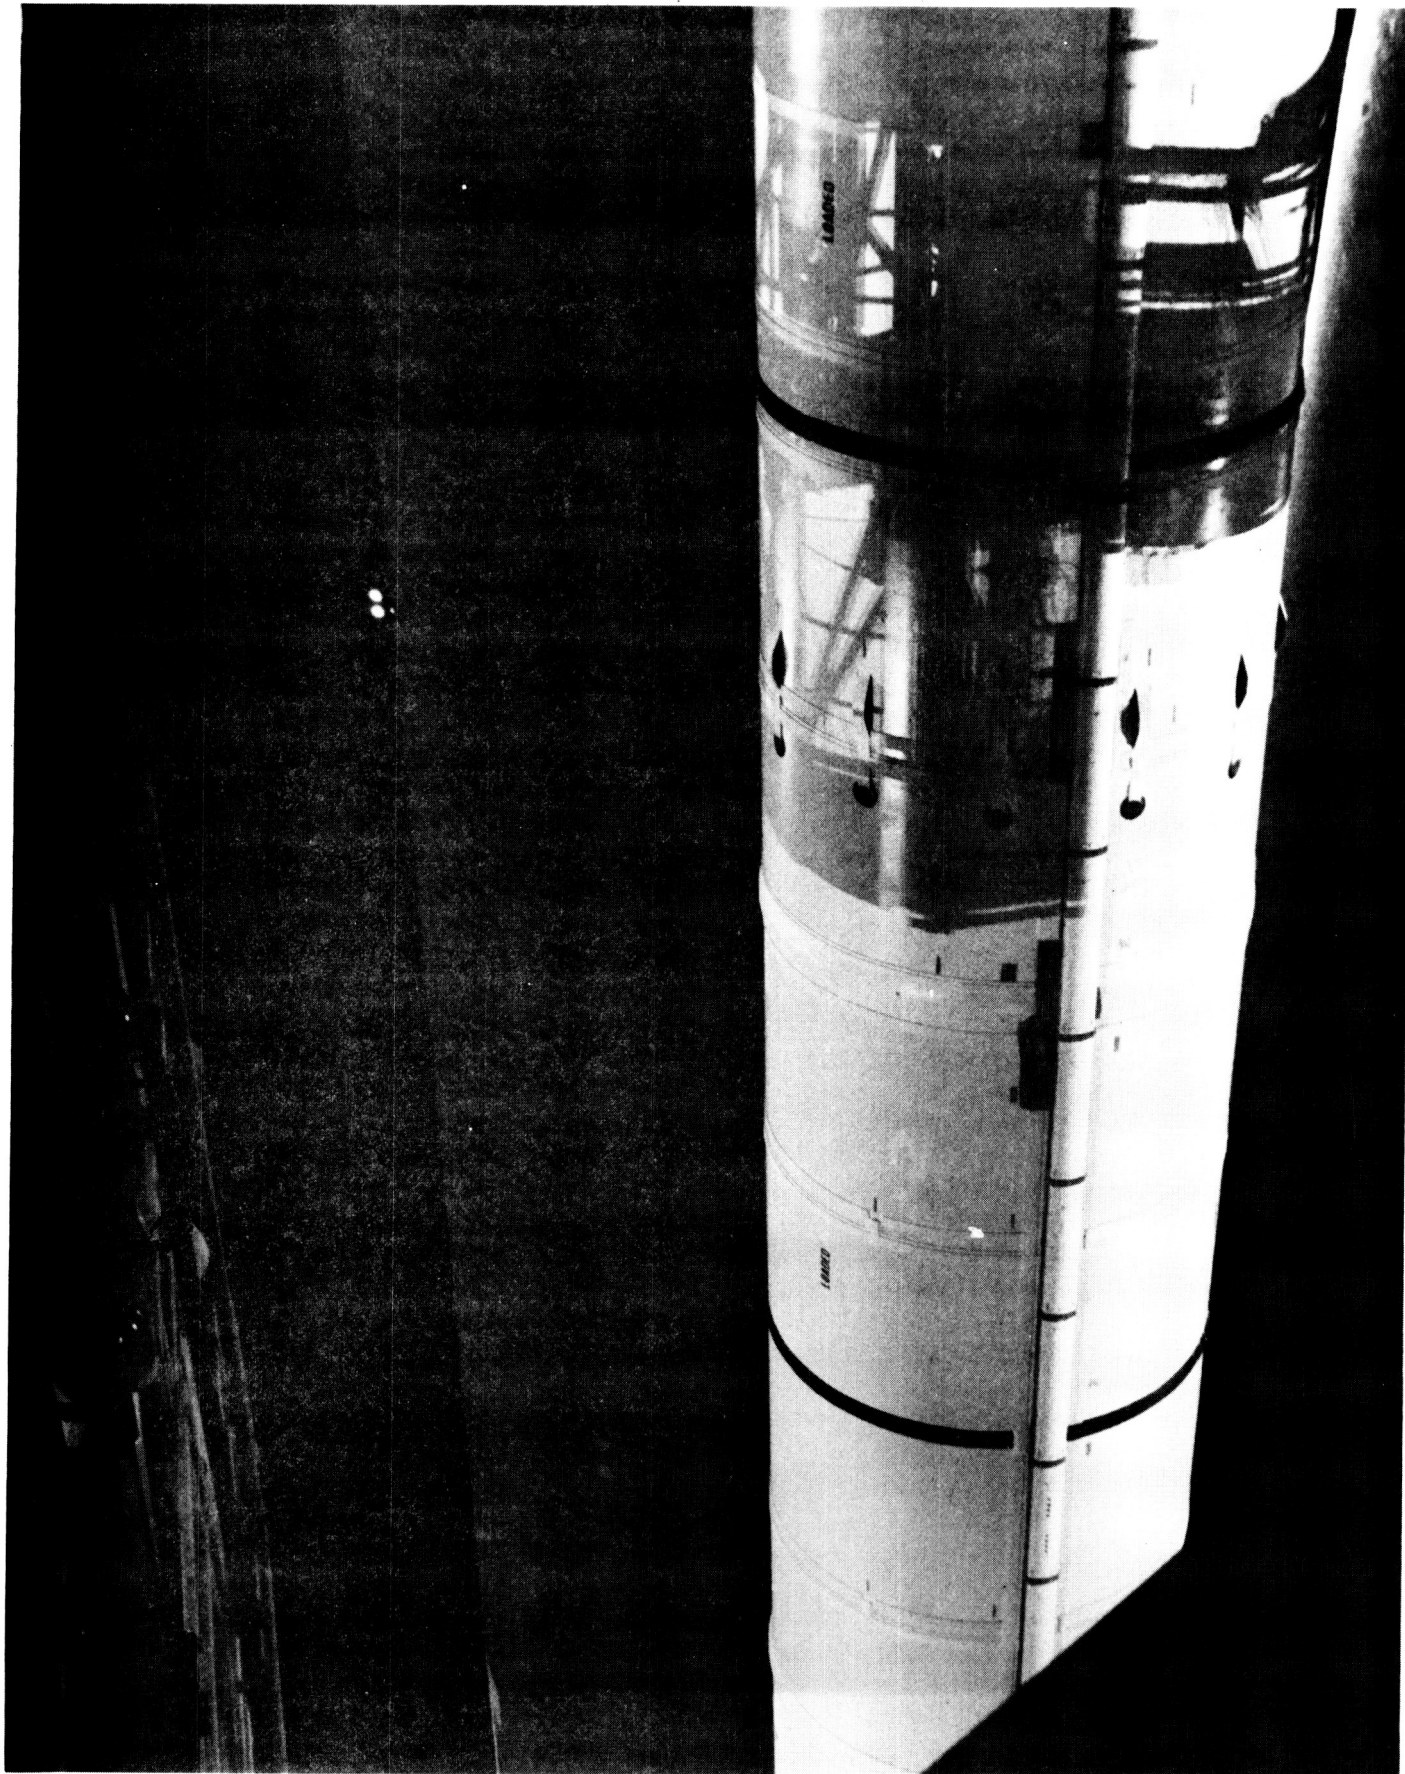
LIGHT CONDENSATE VISIBLE PRIMARILY ON UPPER LH2 TANK BARREL.
ACREAGE FROST ON MID LH2 BARREL AT 315° AZIMUTH.

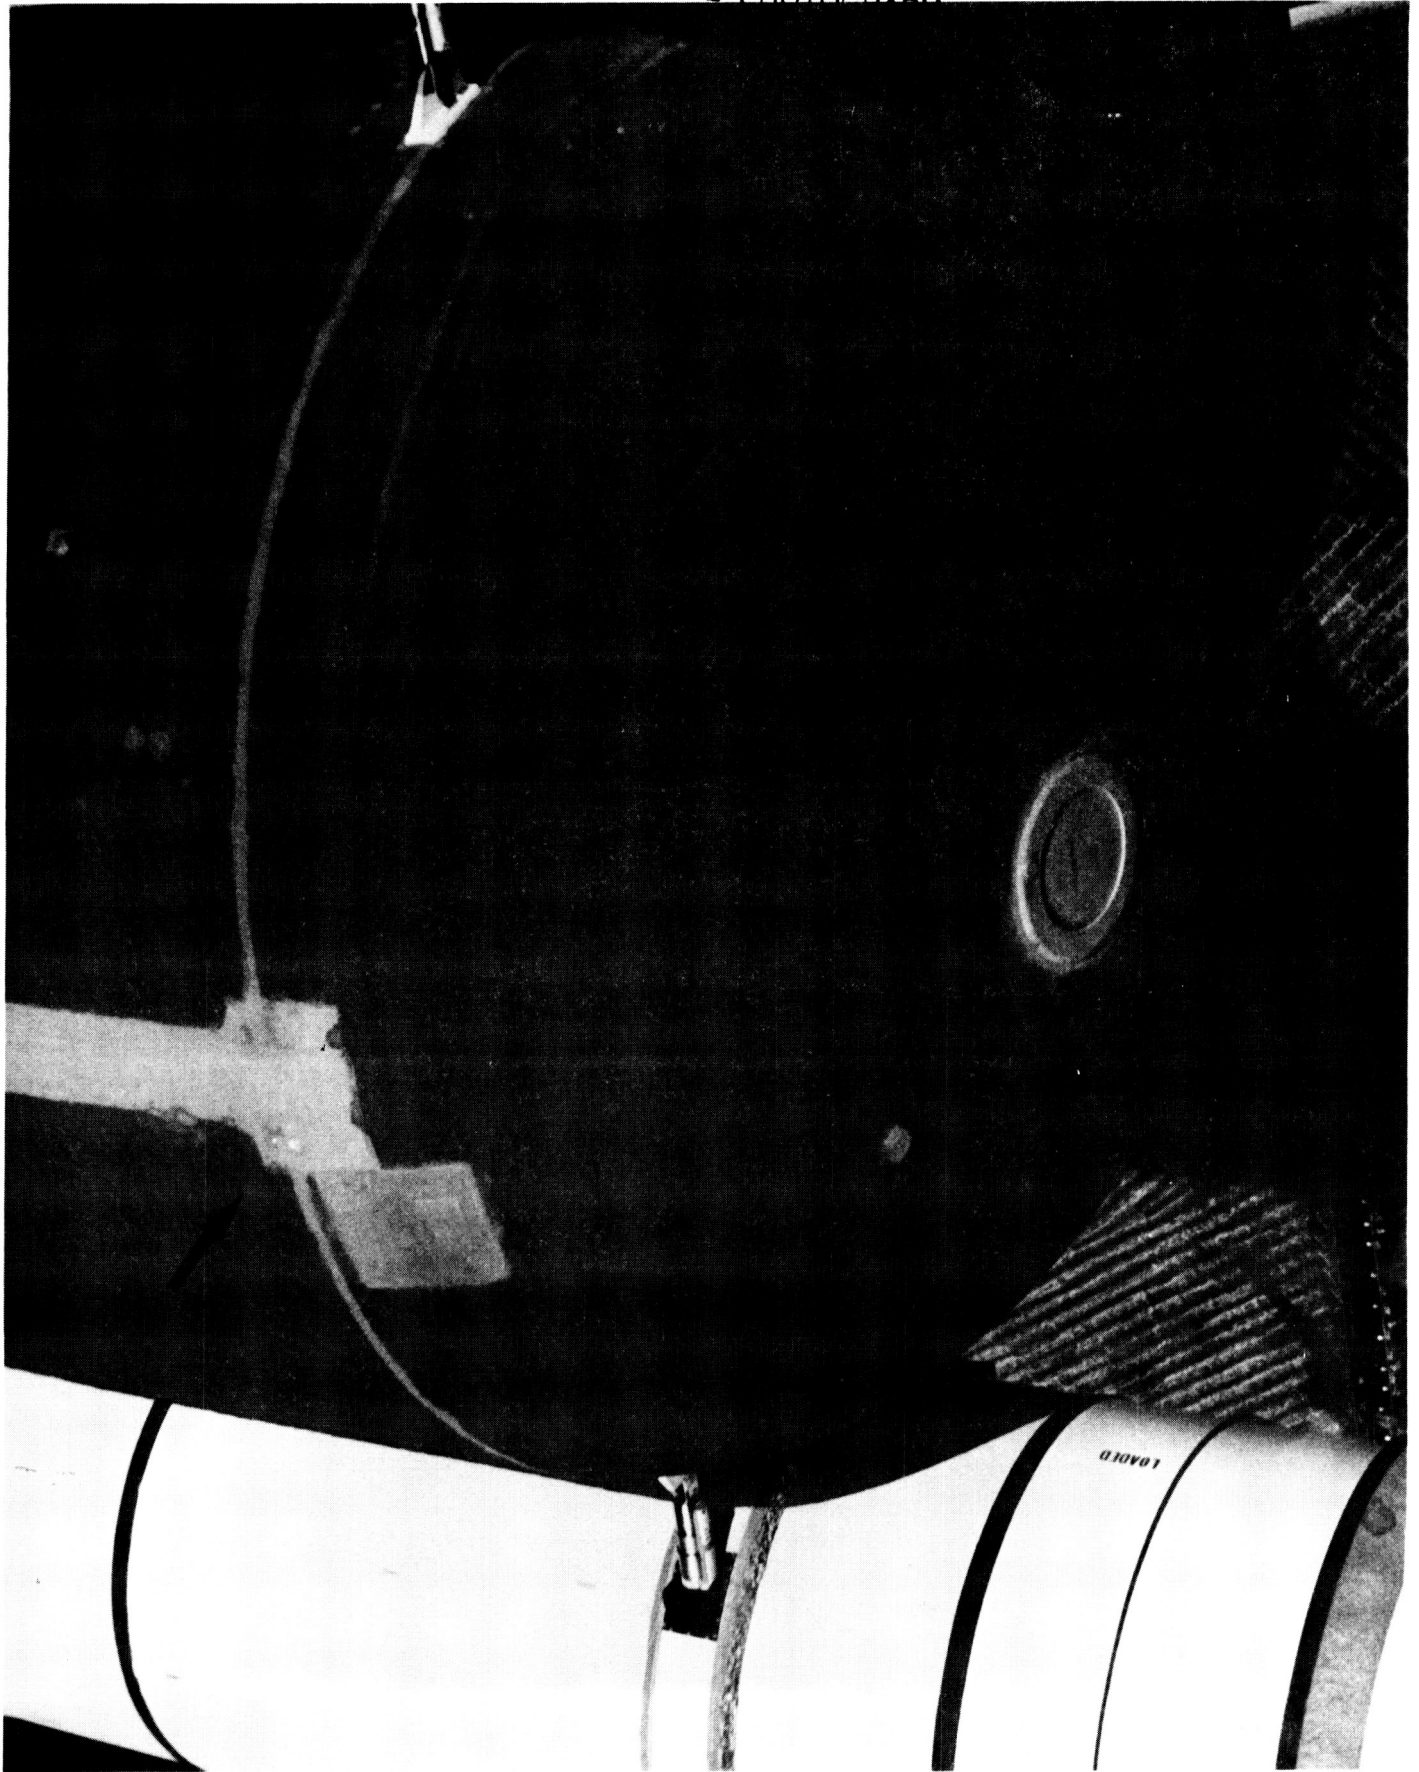
ET LH2 TANK AFT DOME. NOTE FROST ON EB FITTINGS
AND FROST AREAS ON AFT (-Z) HARDPOINT CLOSEOUT.

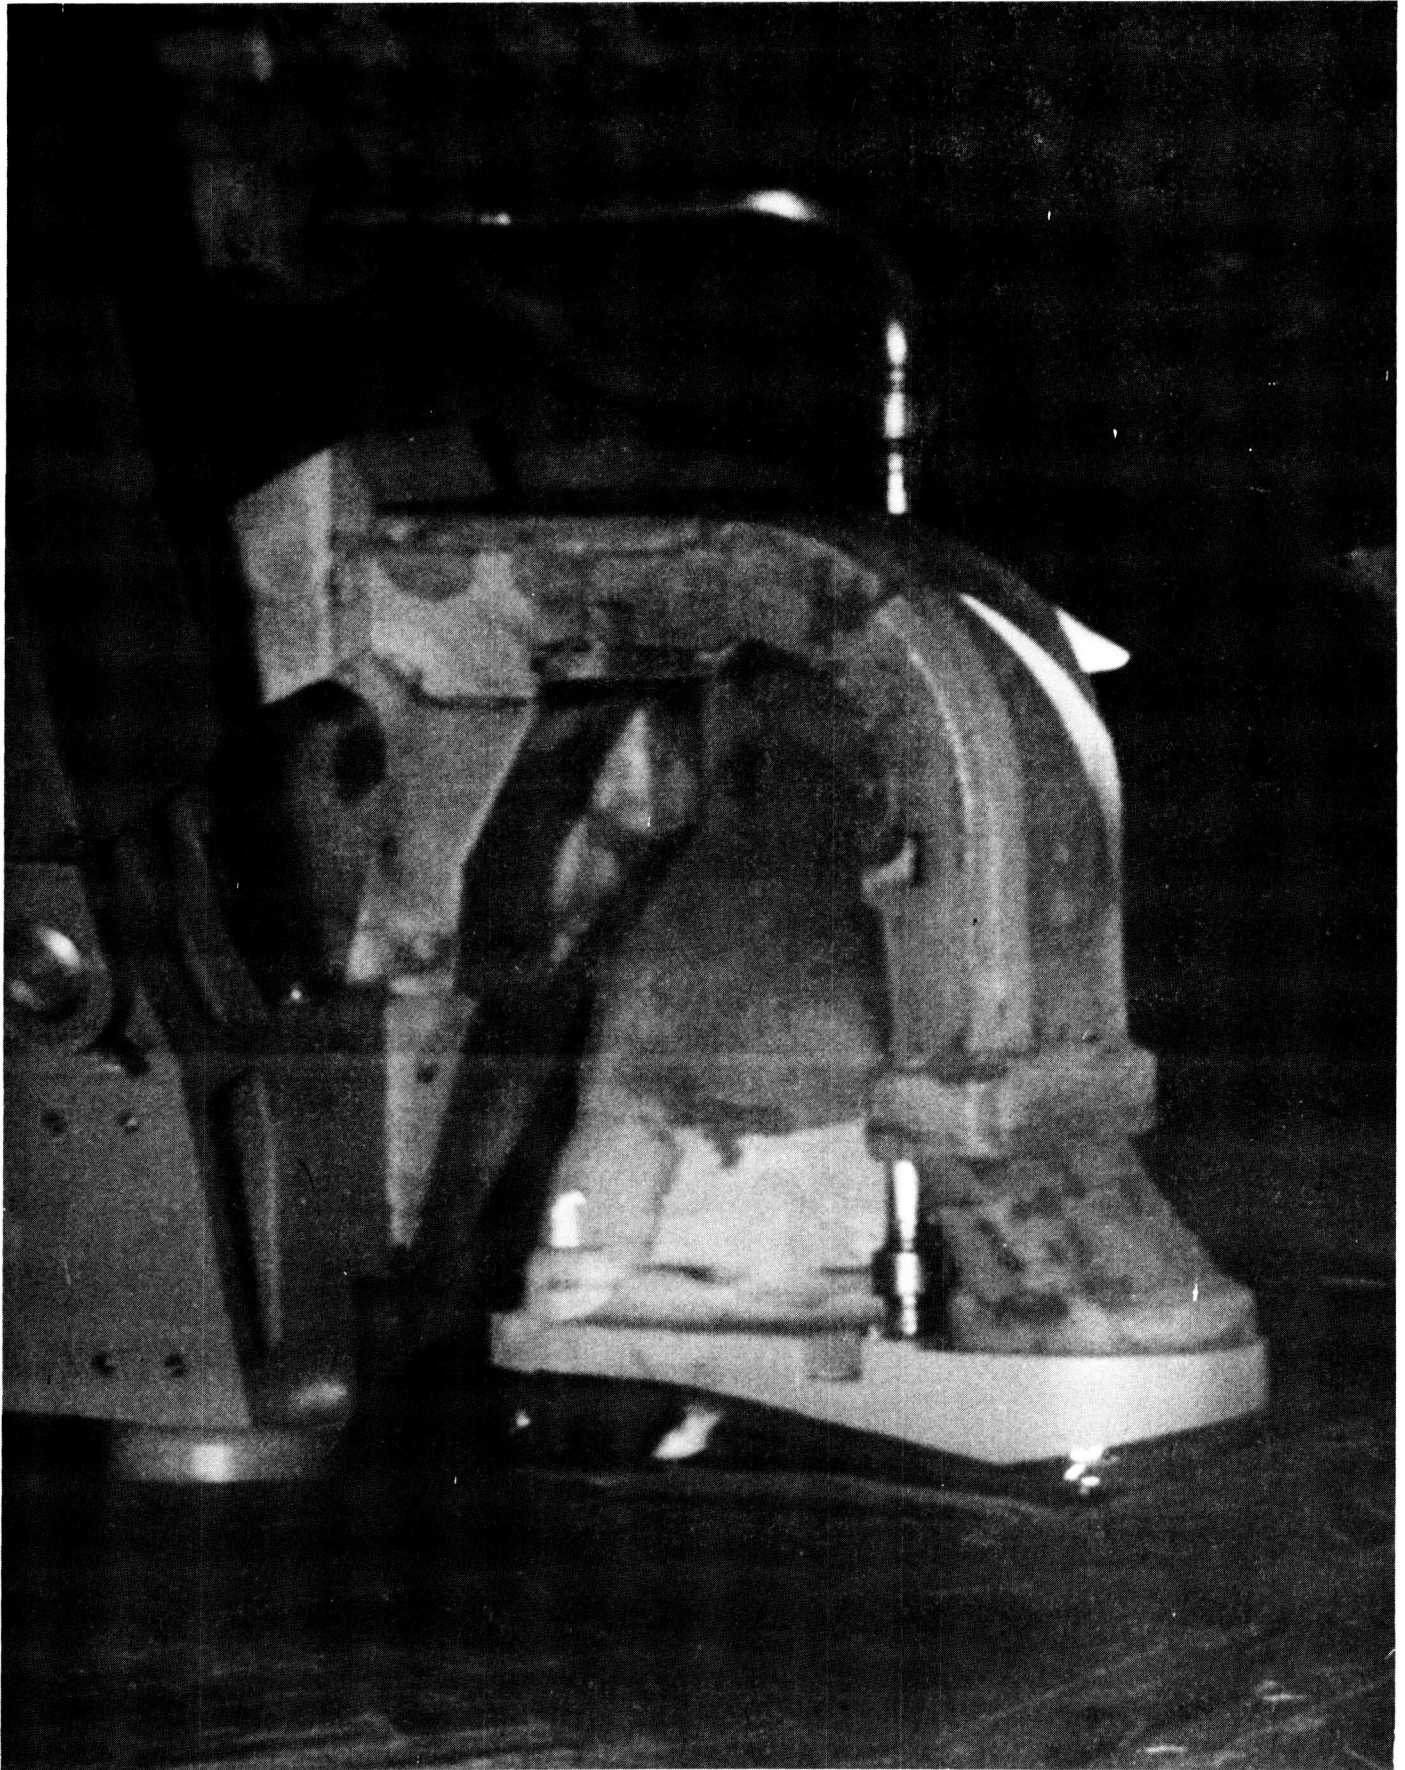
LIGHT ICE/FROST ACCUMULATION ON ET/ORB LO2 UMBILICAL.
TYPICAL FROST FINGER ON PURGE VENT.

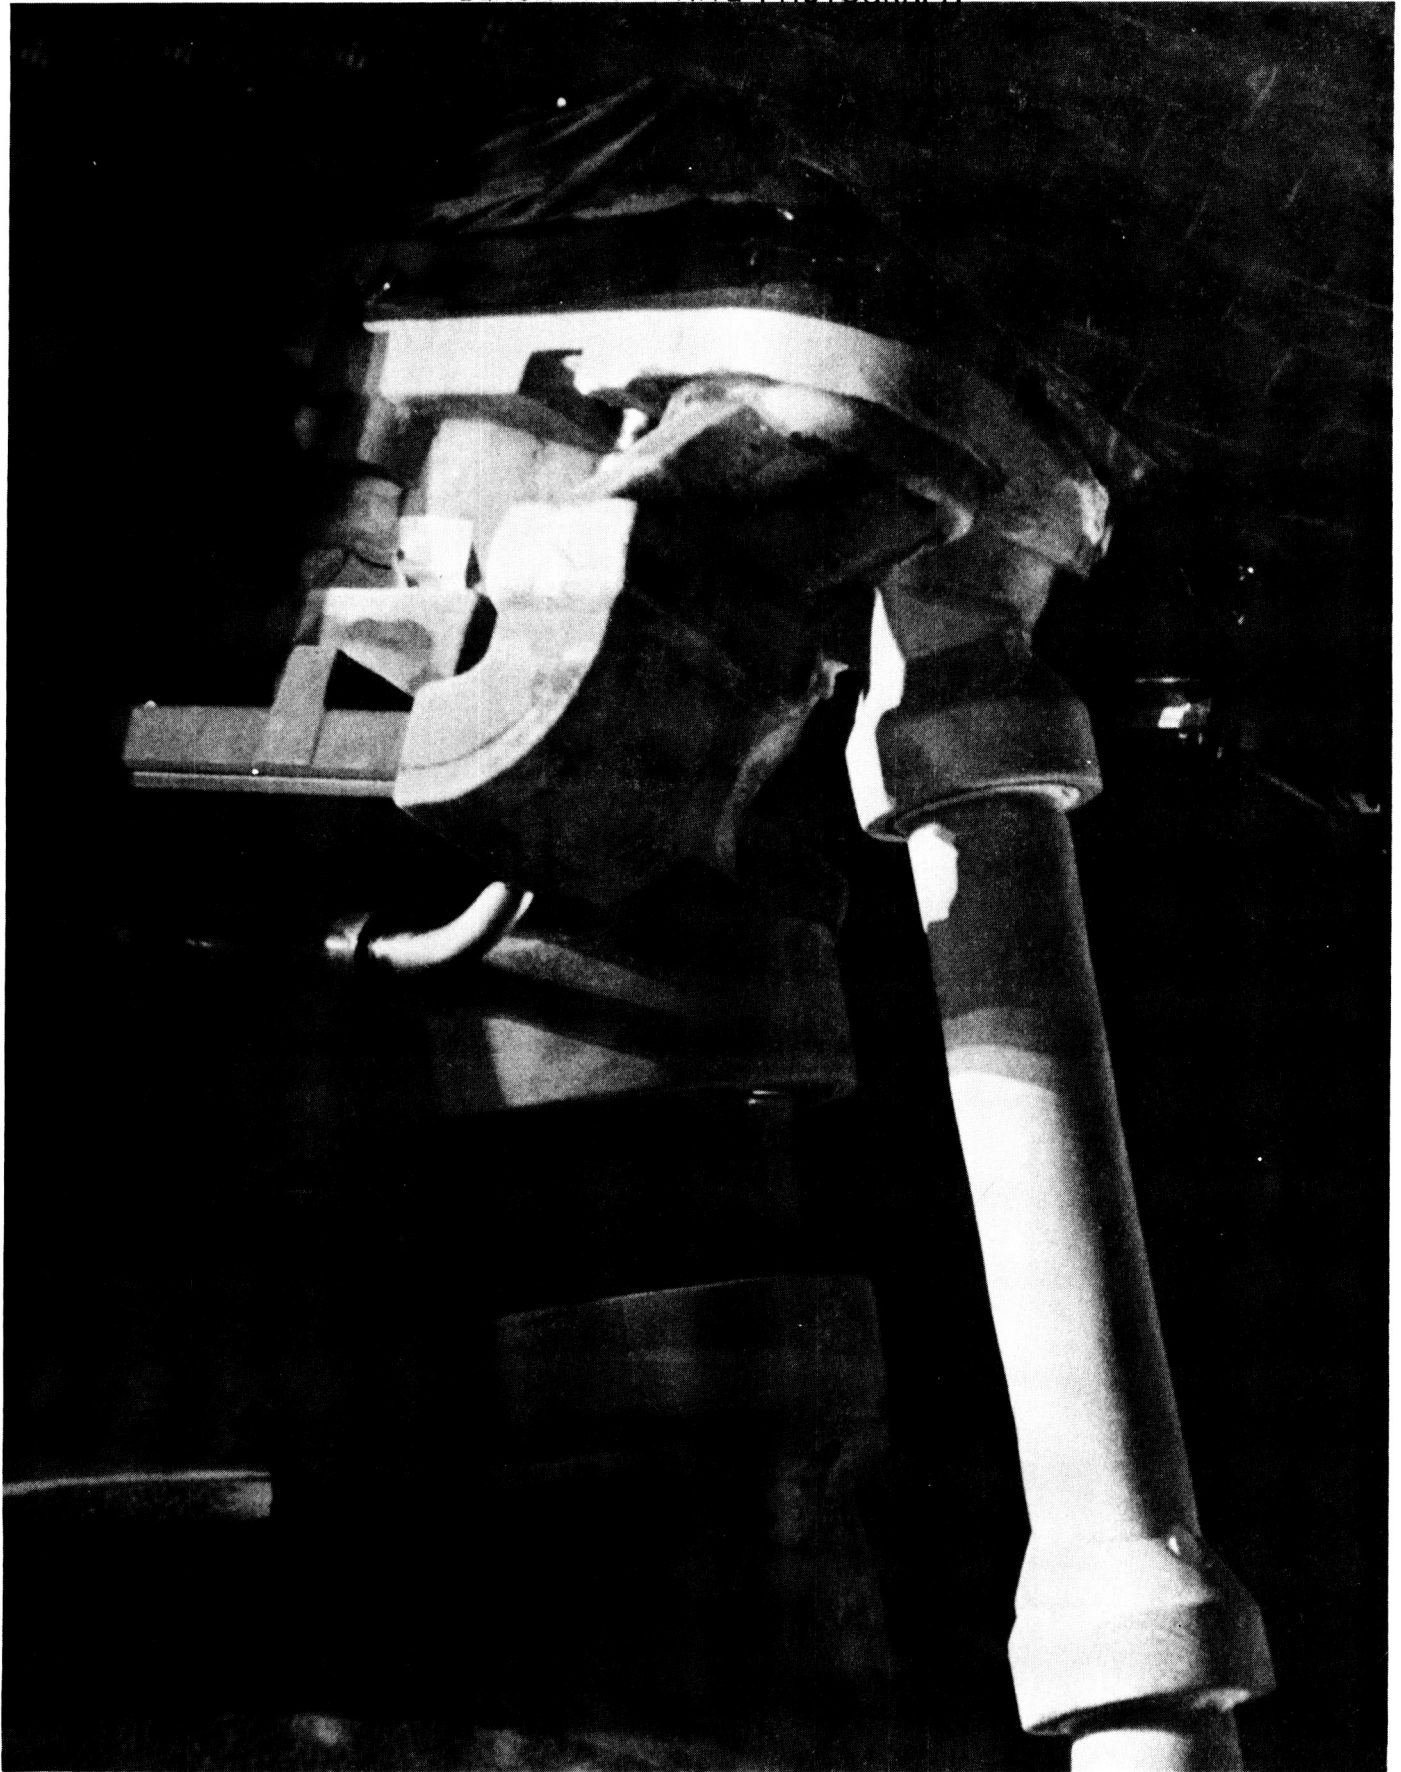
LIGHT ICE/FROST ACCUMULATION ON ET/ORB LH2 UMBILICAL.
TYPICAL FROST FINGER ON PURGE VENT.

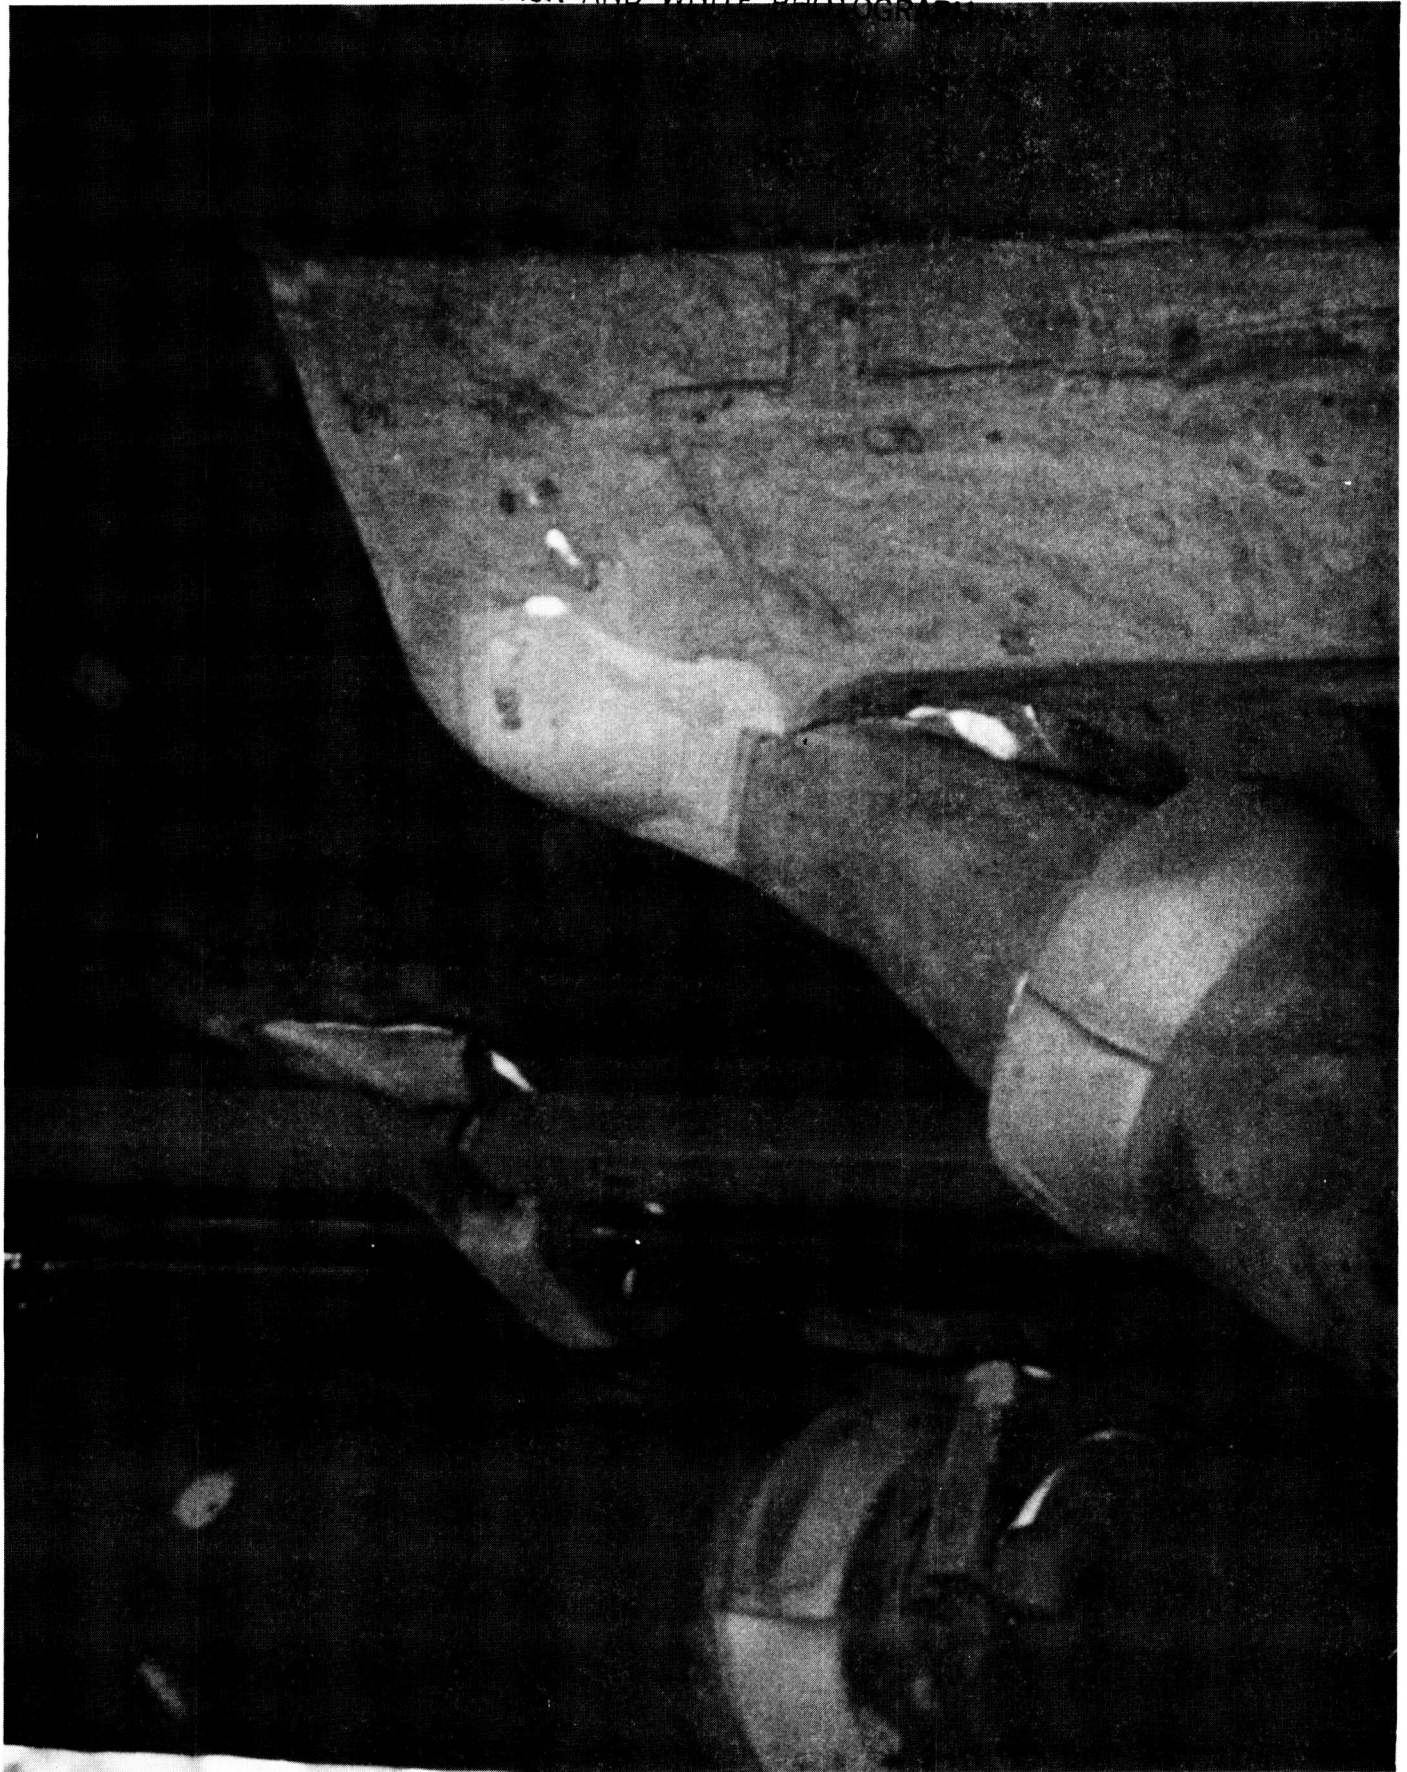
ICE/FROST ACCUMULATION ON CRACK IN +Y THRUST STRUT CROTCH AREA
AND IN THREE AREAS ON THRUST STRUT KNUCKLE

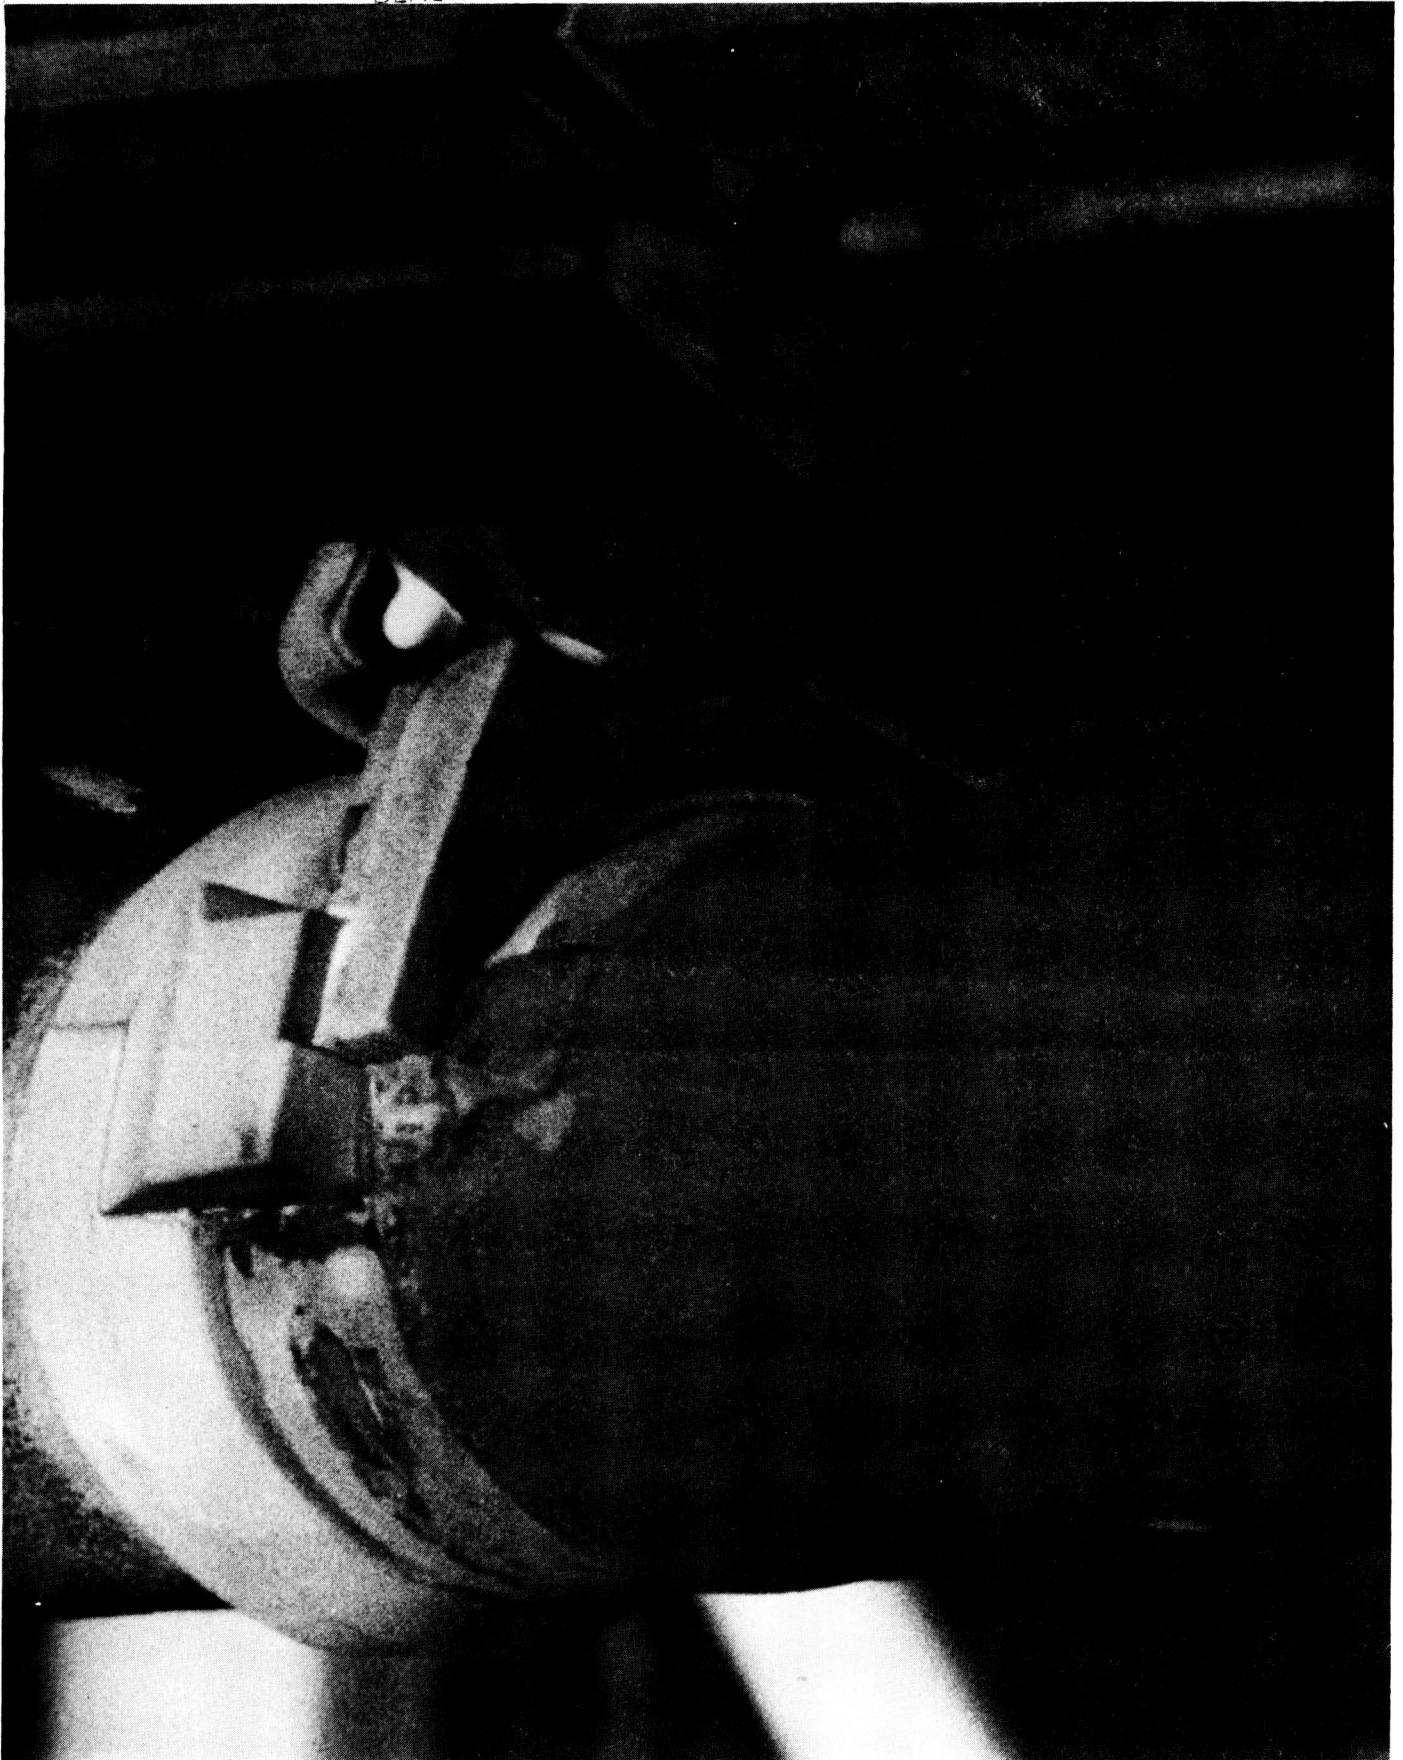
ICE/FROST IN LO2 FEEDLINE SUPPORT BRACKET XT 1623
